Identifying Patterns of Lumberyard Mold

By: Patrick Moffett, REA, CHMM

Science behind identifying Sap Stain Fungi

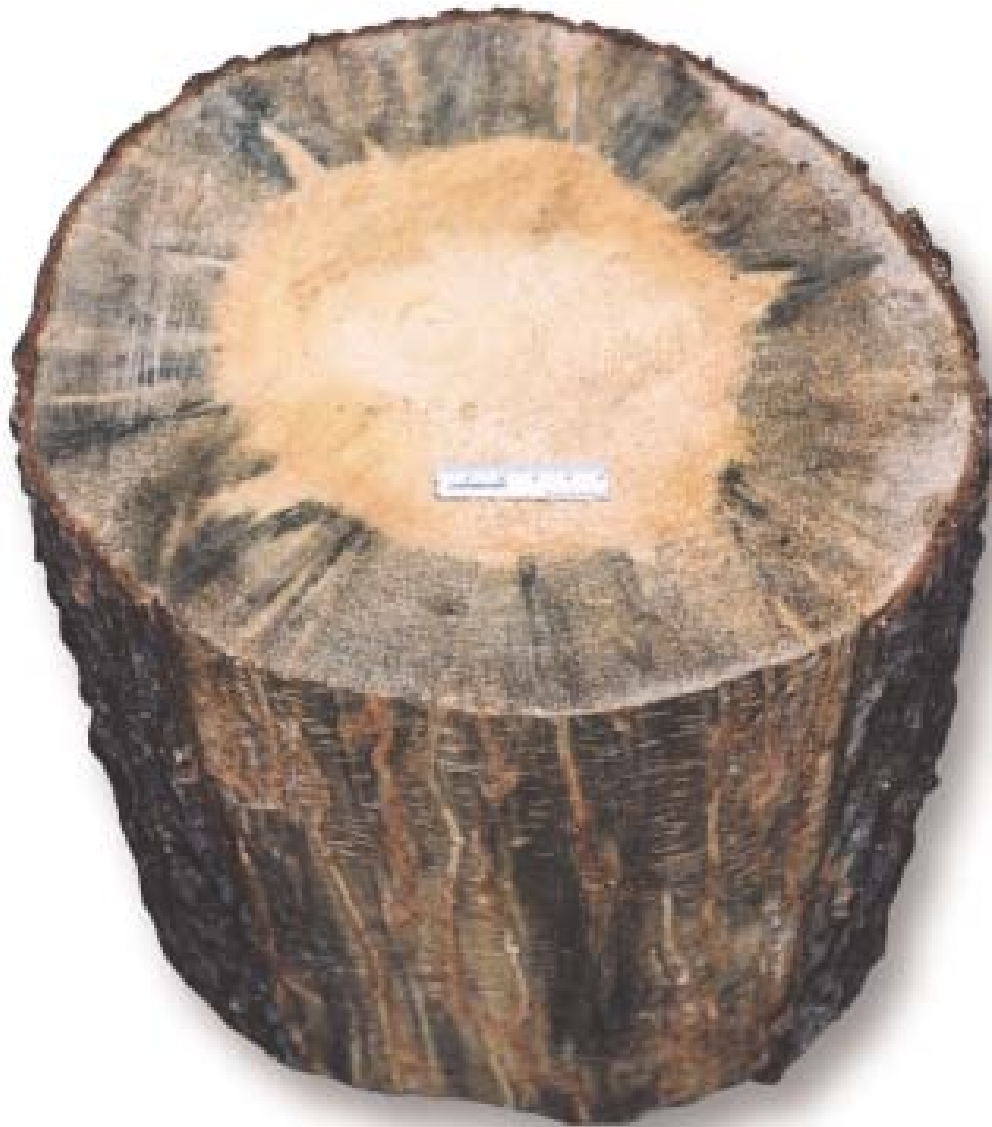
Picture courtesy of Forintek. Canada's wood products research institute.

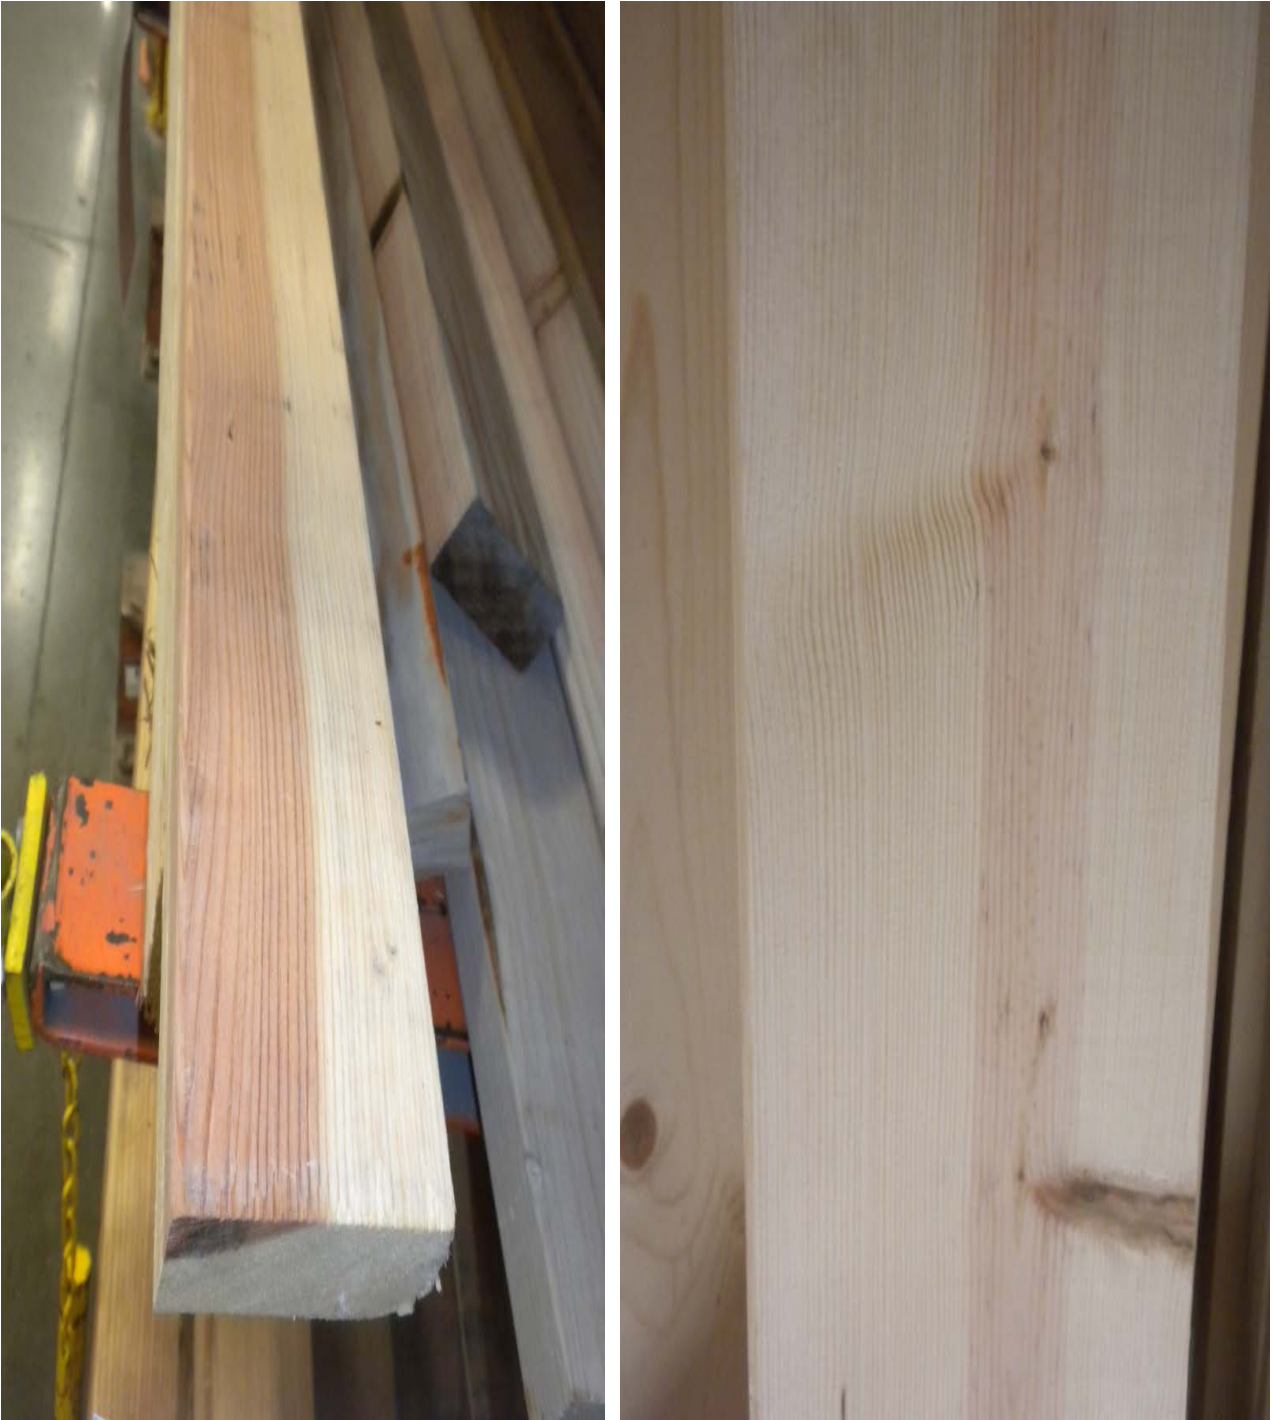
Which color of wood represents the heartwood?

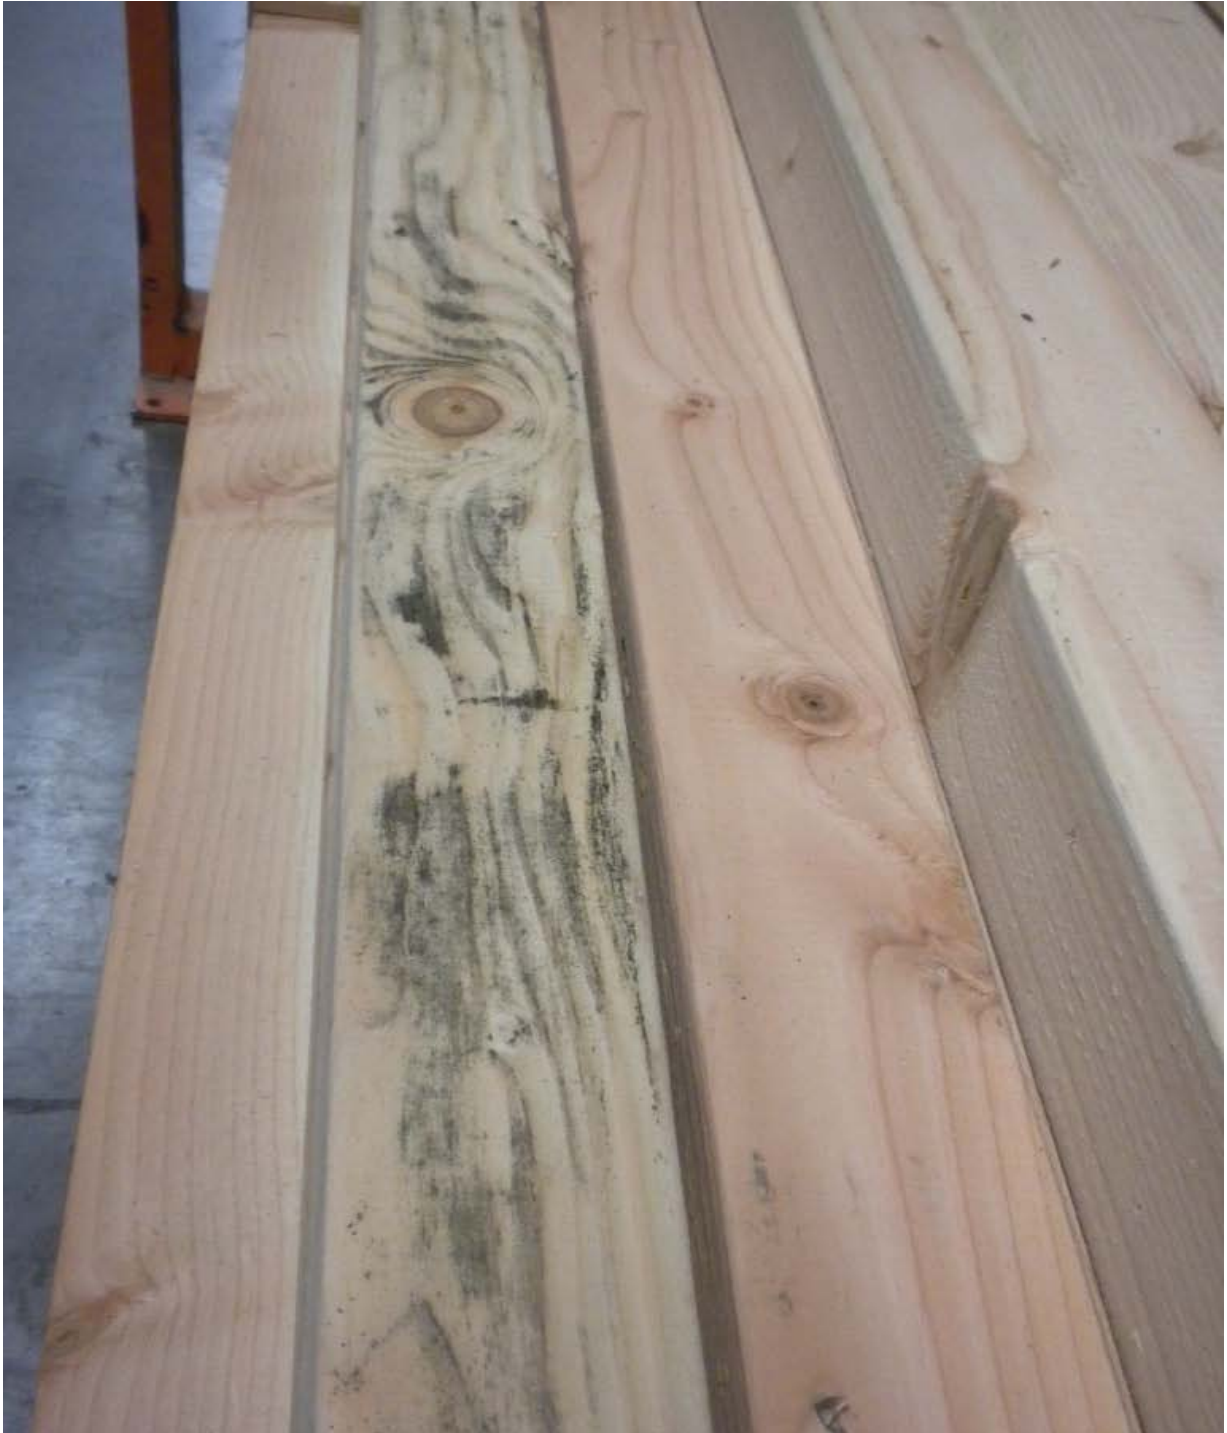
Which 4 x 4 piece of lumber has lumberyard mold on it? Do you see lumberyard mold on the right or left piece? If you don't see lumberyard mold on the right or left piece why not? From a construction point of view should the 4 x 4 piece of lumber with sap staining be disposed?

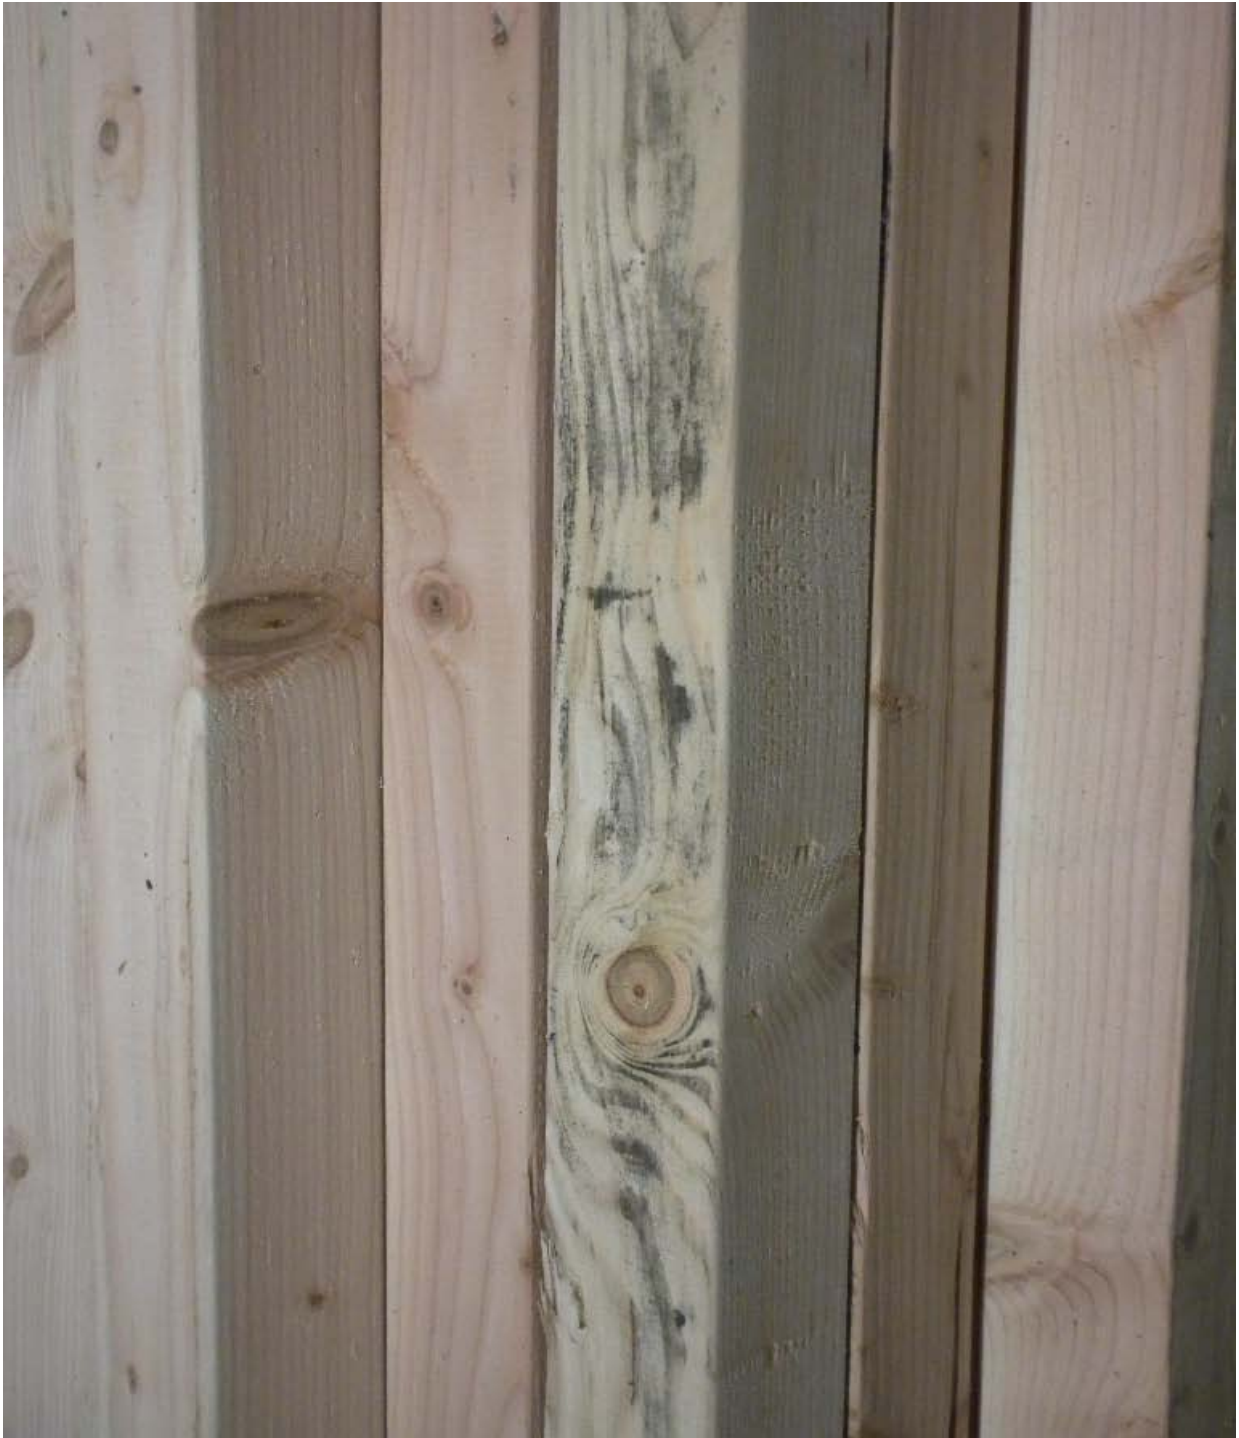
Which piece of wood has sap staining (lumberyard mold)?

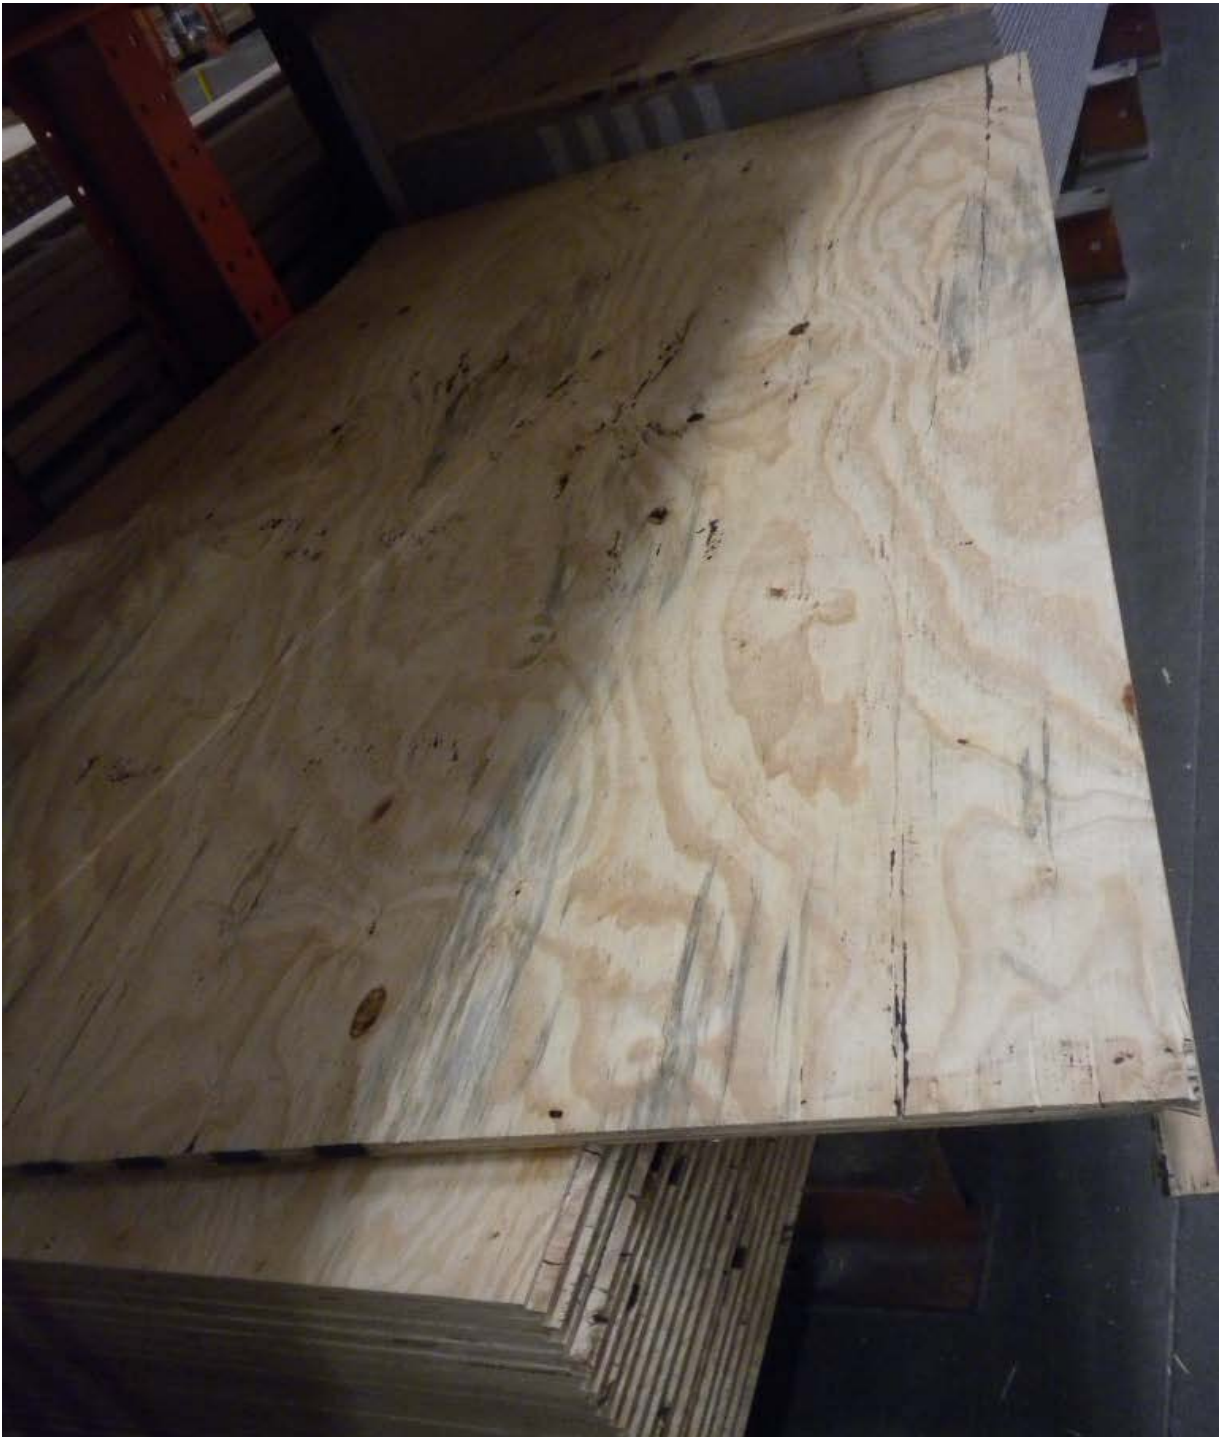
Picture shows wood panel having deep blue sap staining. Investigation showed sap staining is on every panel. Since panels are made in plies the middle ply may have sap staining. Should these panels not be used in building construction?

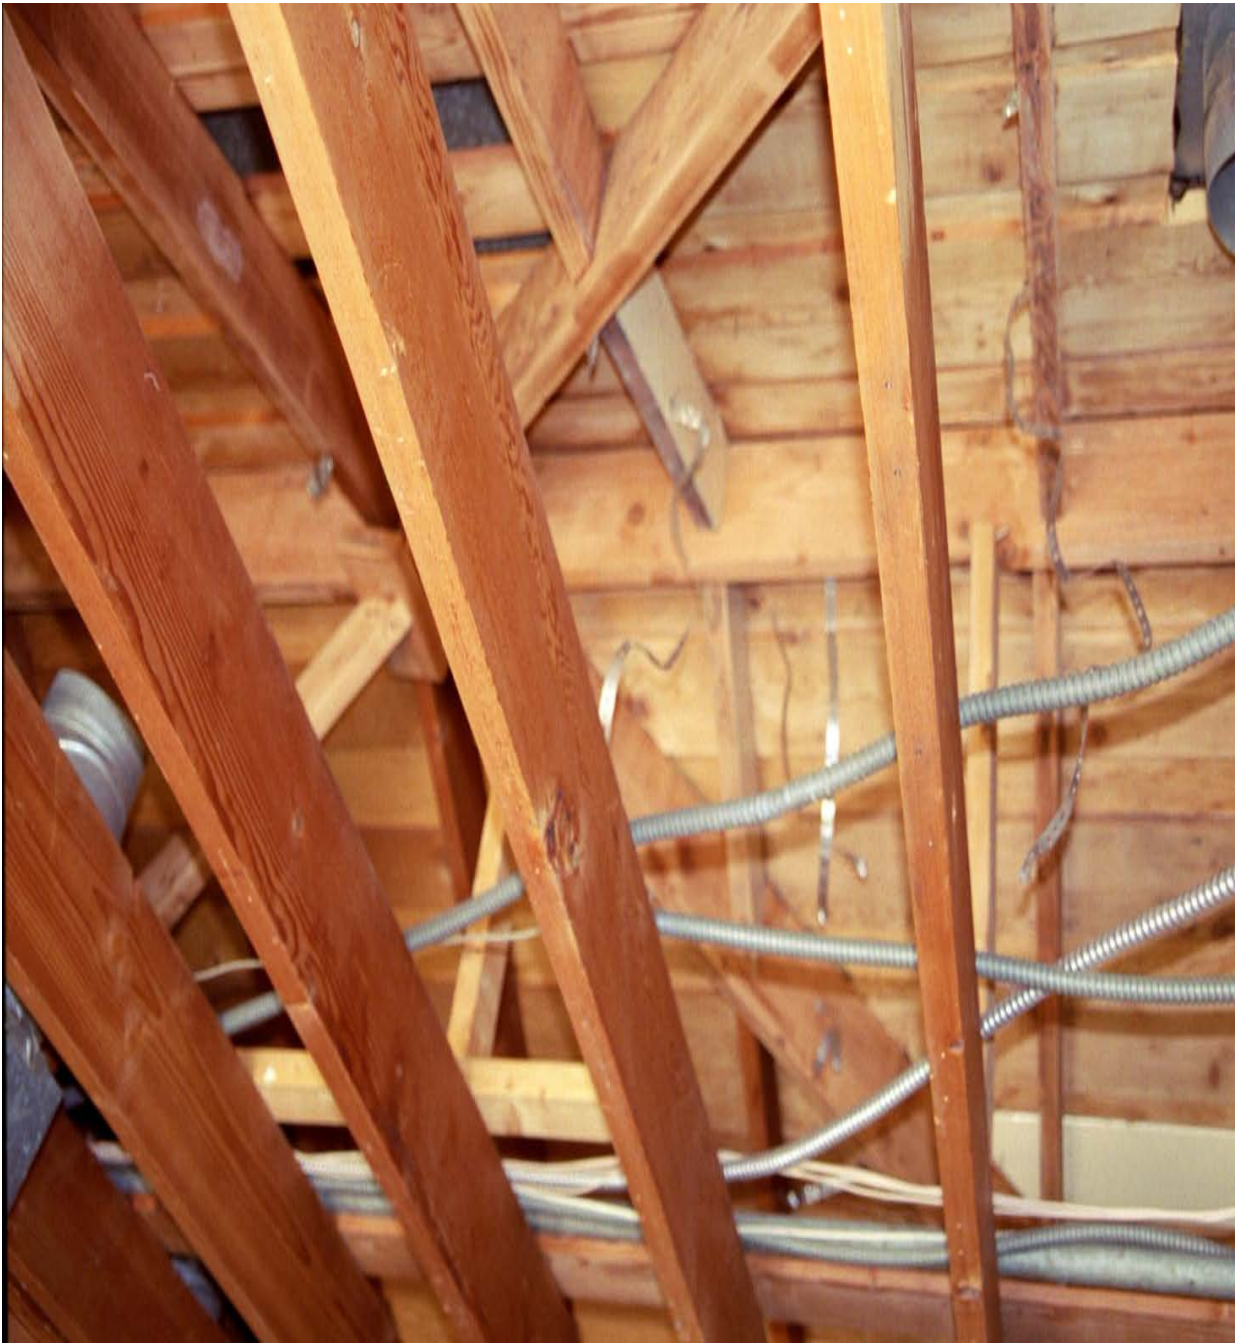
After mold remediation, picture shows building framing without visible signs of mold growth and lumberyard mold. One can see the graining of wood where there is lighter and darker coloring.

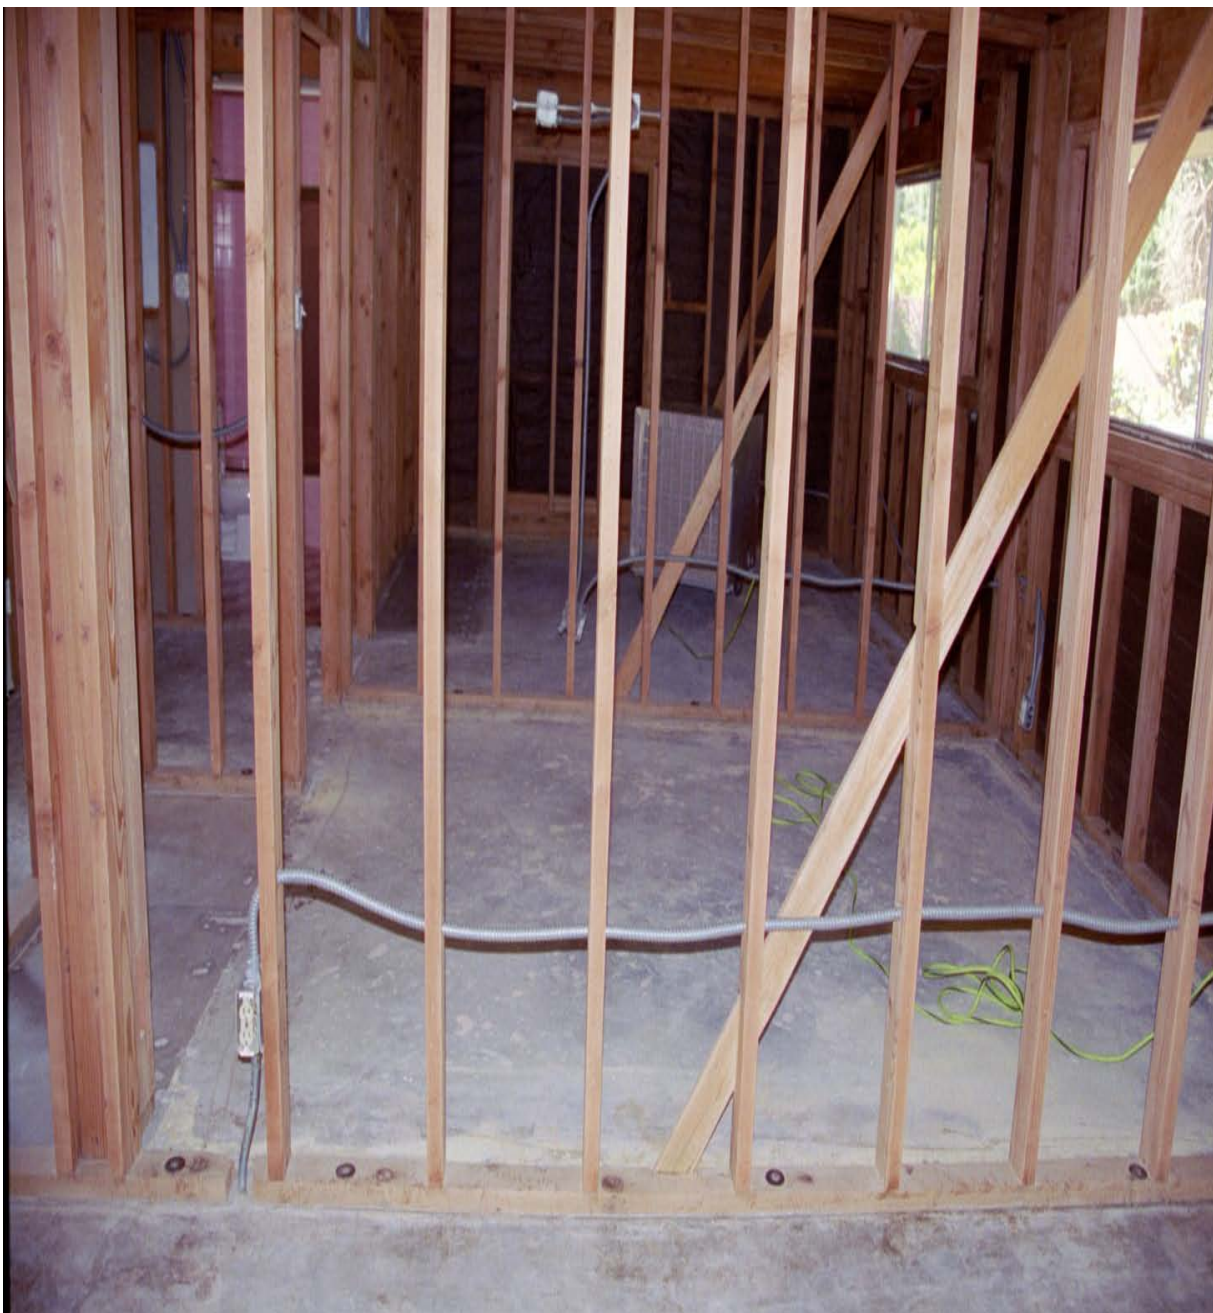
Building framing after mold remediation.

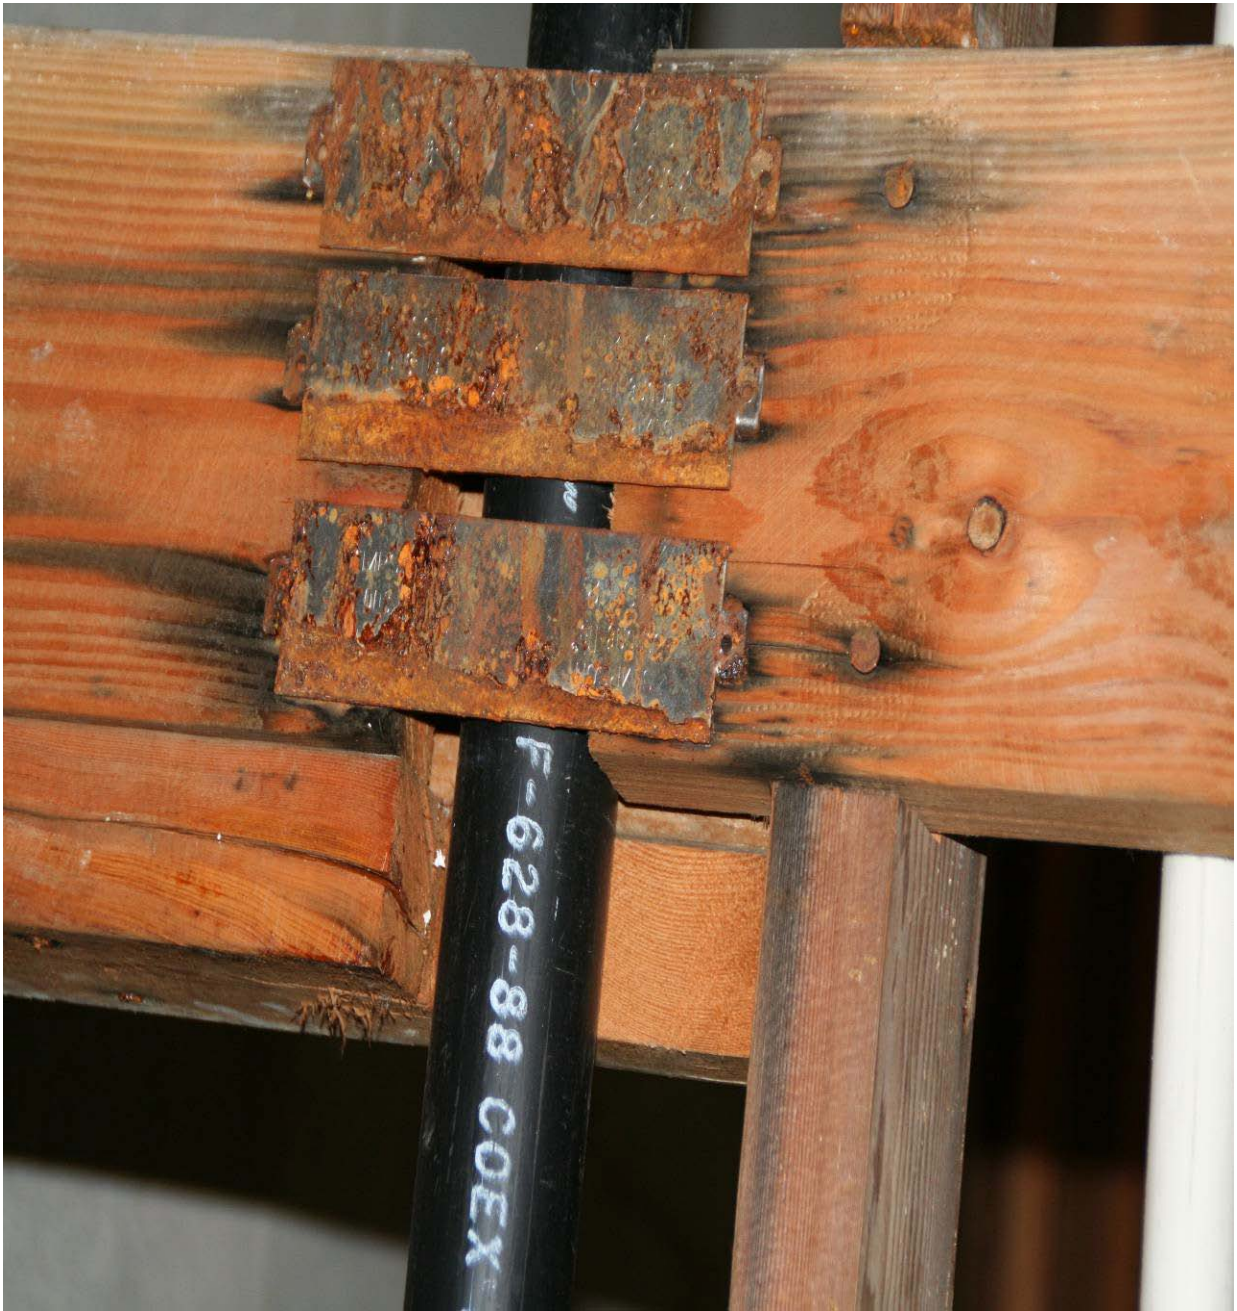
Building framing with wood staining from metal clips (staples).

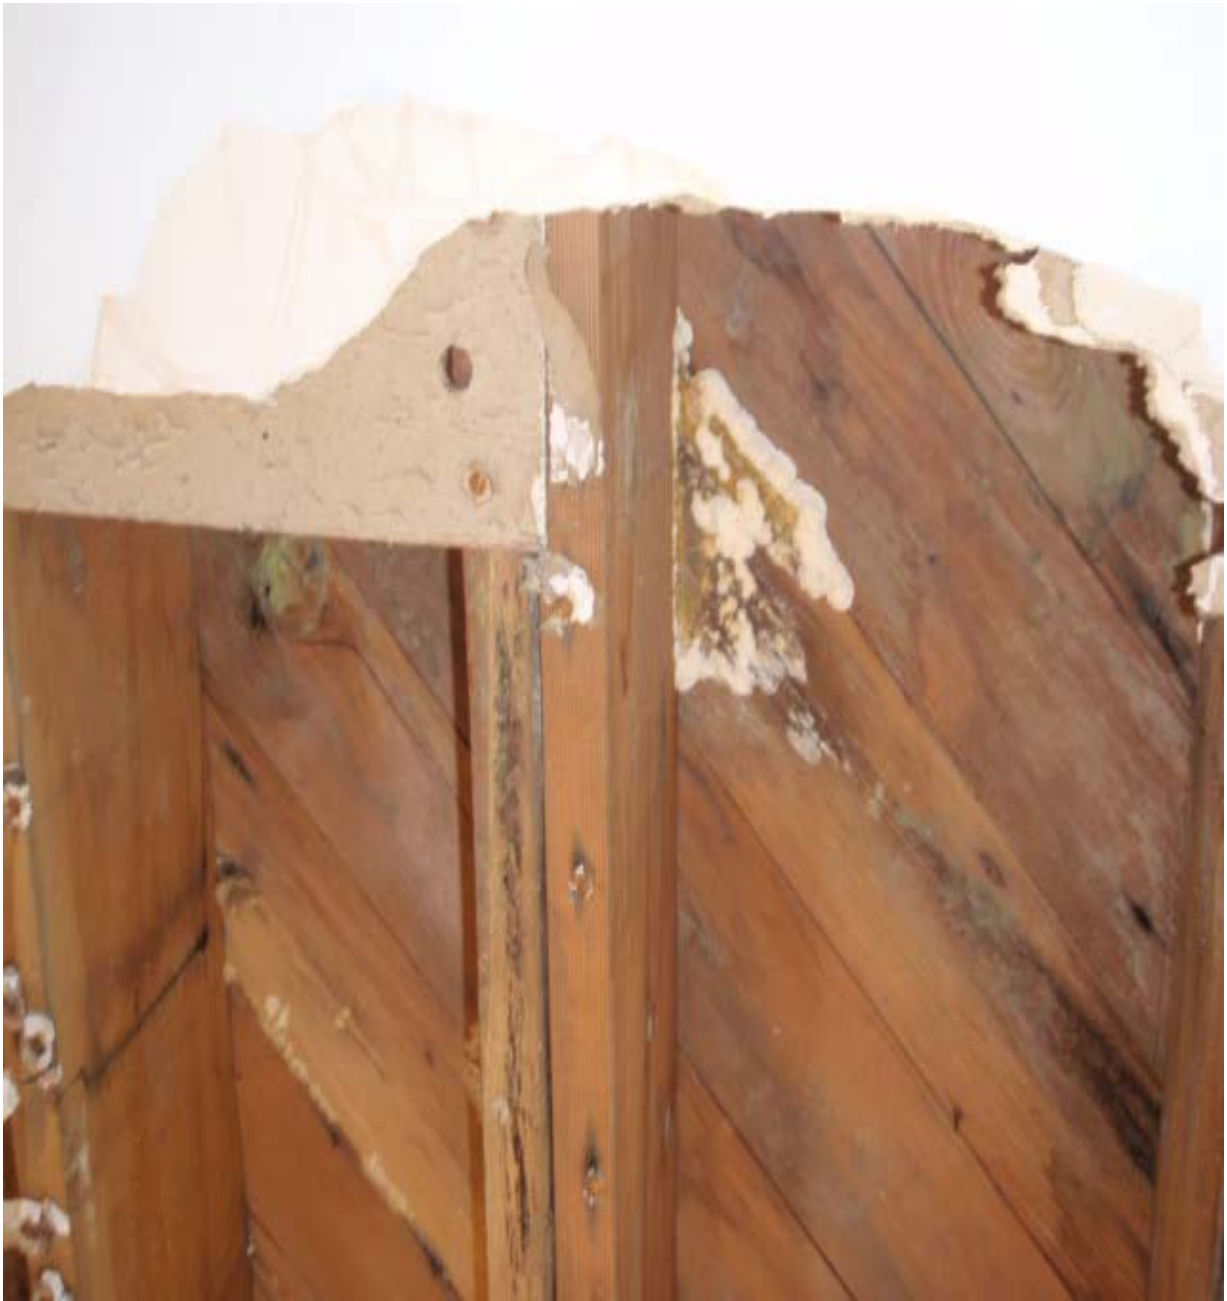
Many issues are in this picture involving mold growth from water damage including the second floor subfloor, first floor ceiling joists and drywall. From this picture can you identify the lumberyard mold?

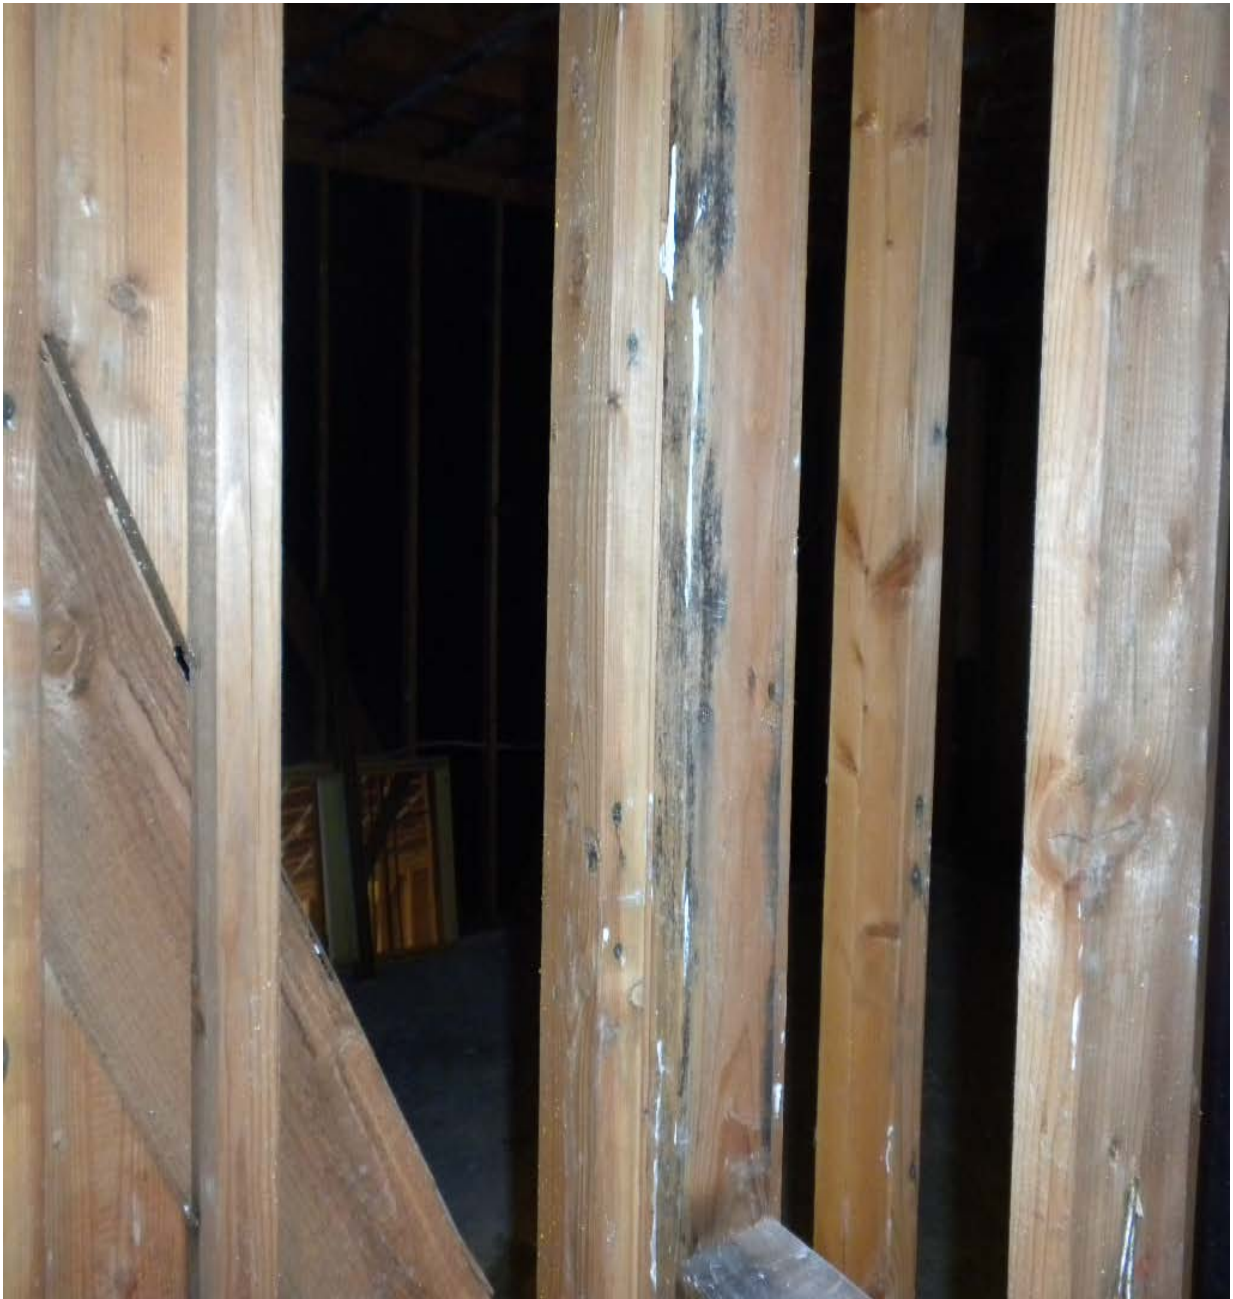
Heartwood doesn't support sap staining but the lighter color sapwood will. From the picture above can you tell what sections of lumber are made from heartwood and sapwood? Which piece of lumber has sap staining?
