Identifying Patterns of Lumberyard Mold

By: Patrick Moffett, REA, CHMM

Science behind identifying Sap Stain Fungi

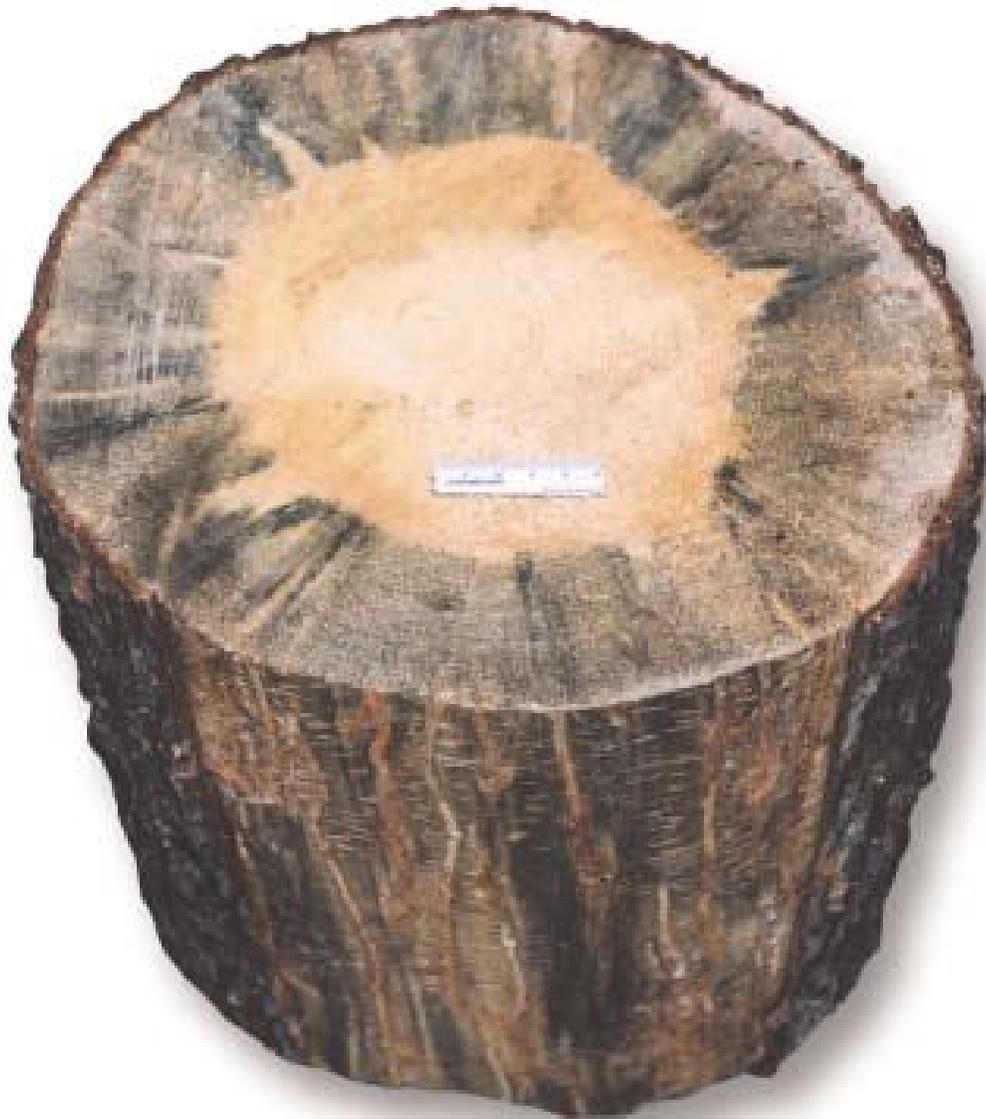
Picture courtesy of Forintek. Canada's wood products research institute.

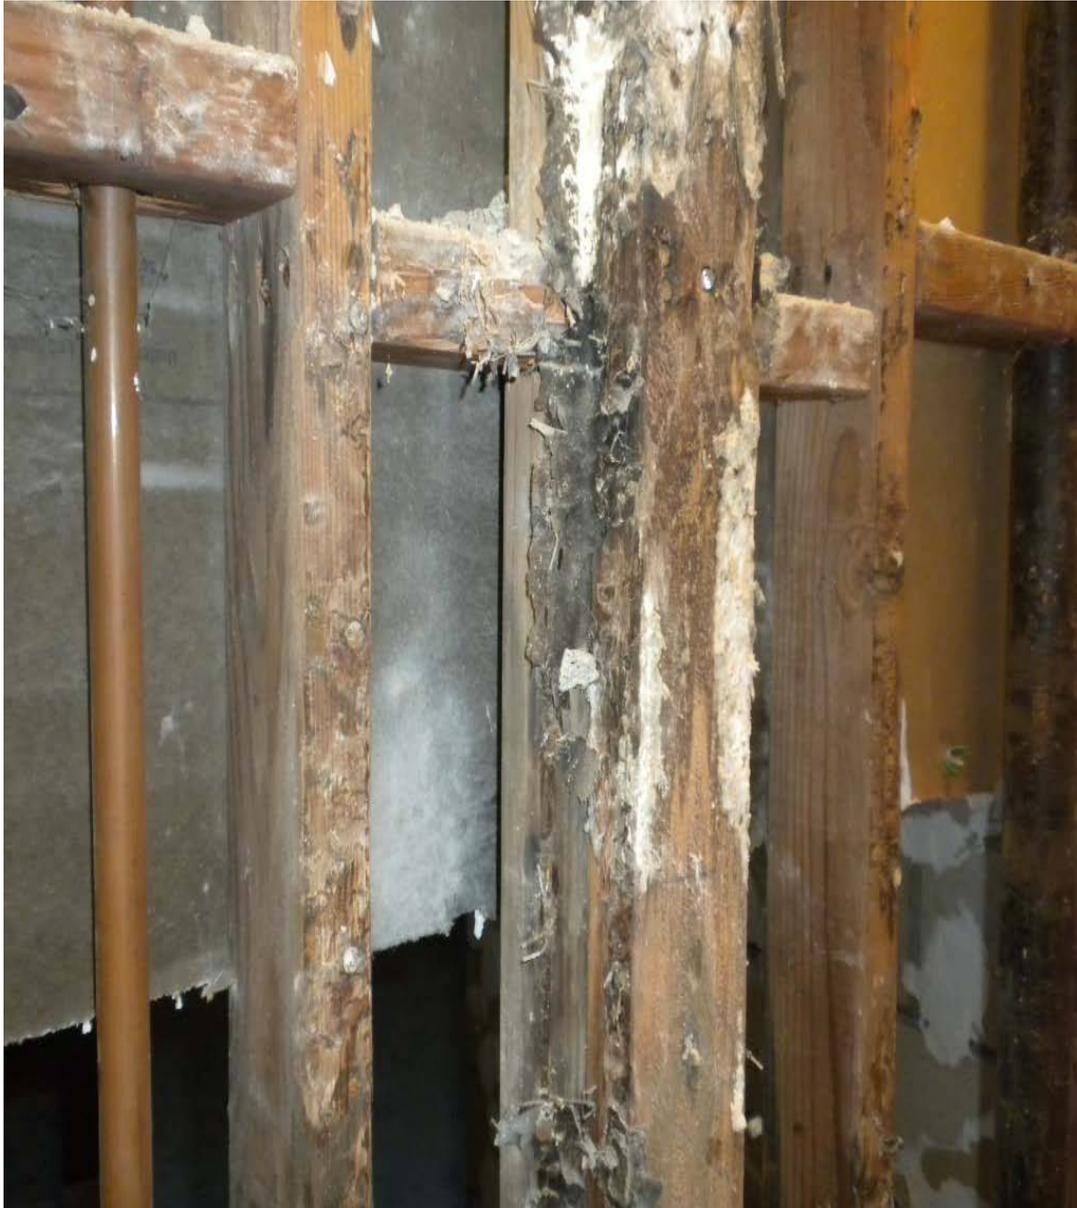
Is it necessary to identify lumberyard mold on this bathroom shower lumber? No. What's required to mitigate damage: Wood rot will be cut out and the remaining framing dried and mold remediated.

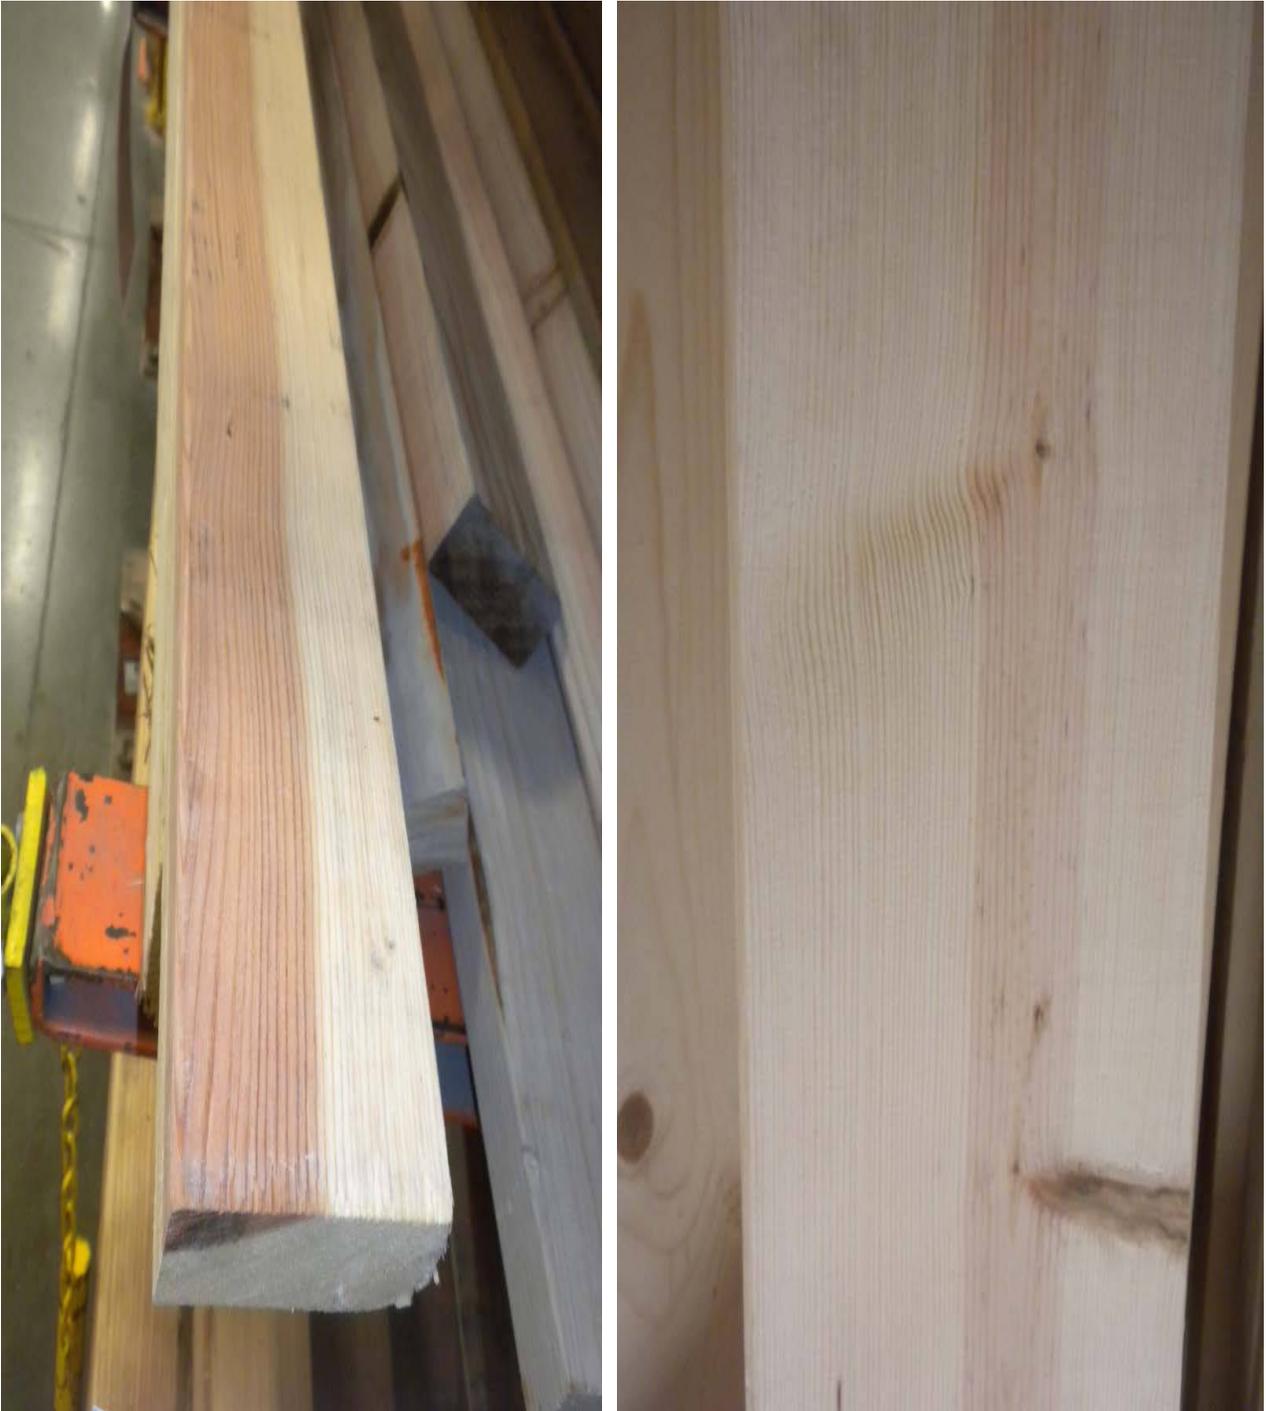
Which color of wood represents the heartwood?

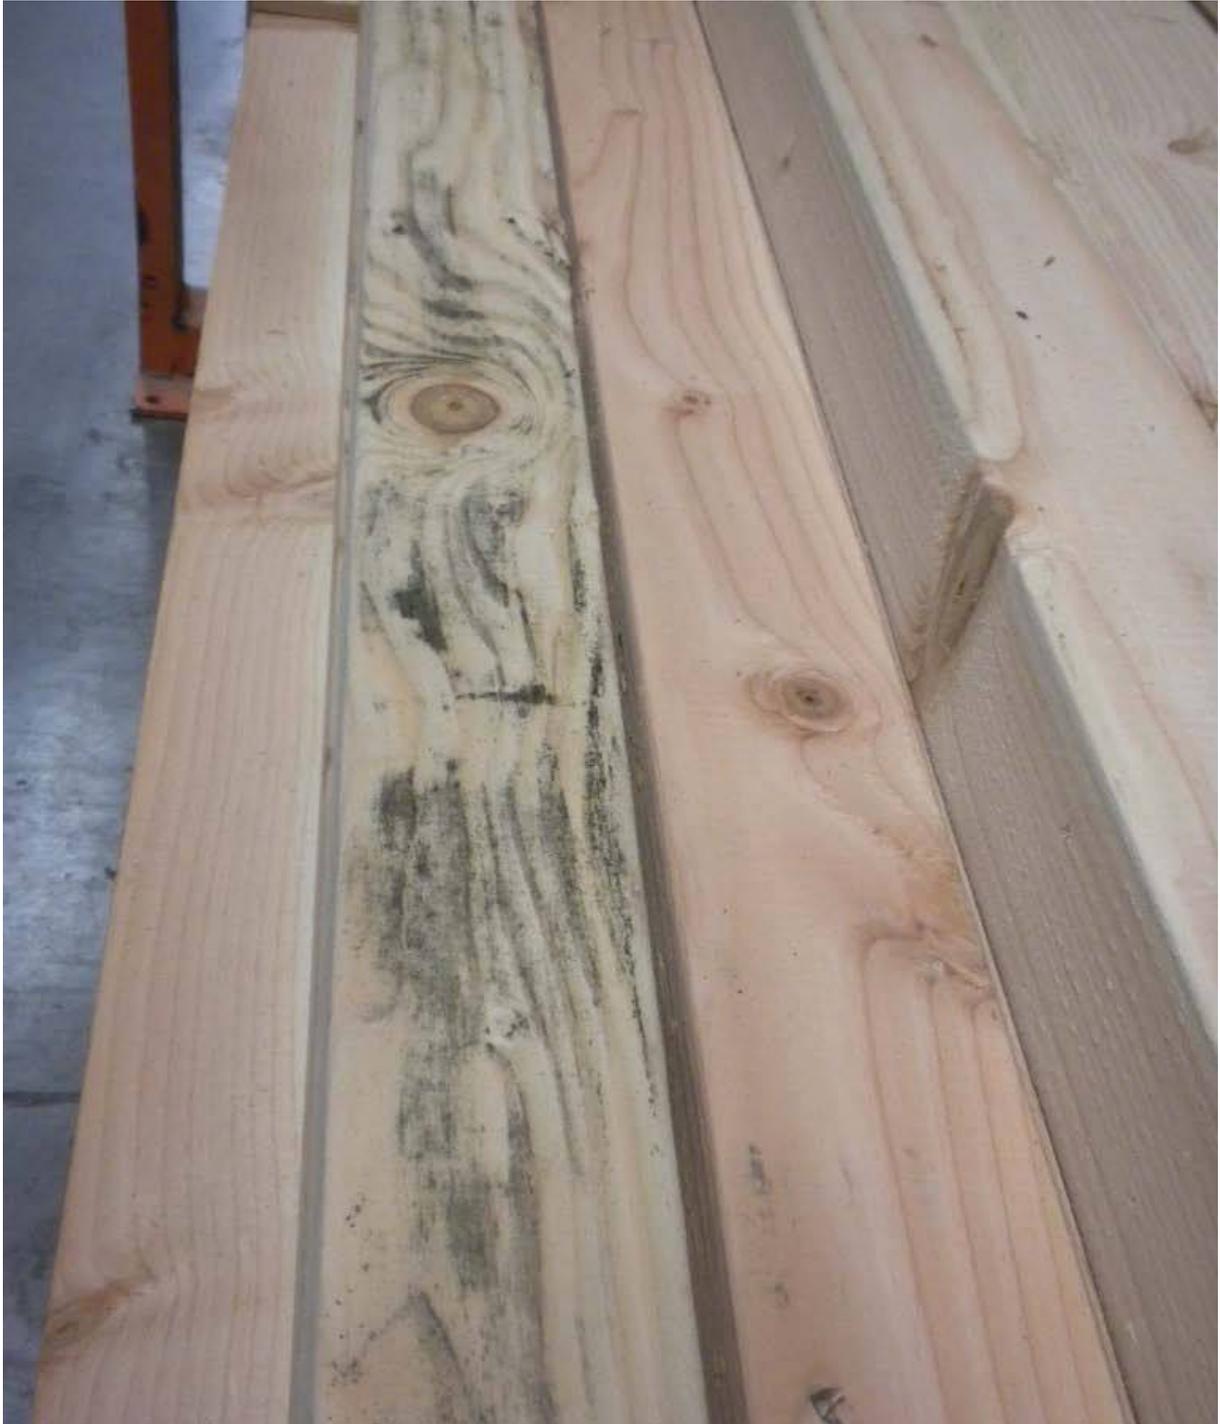
Which 4 x 4 piece of lumber has lumberyard mold on it? Do you see lumberyard mold on the right or left piece? If you don't see lumberyard mold on the right or left piece why not? From a construction point of view should the 4 x 4 piece of lumber with sap staining be disposed?

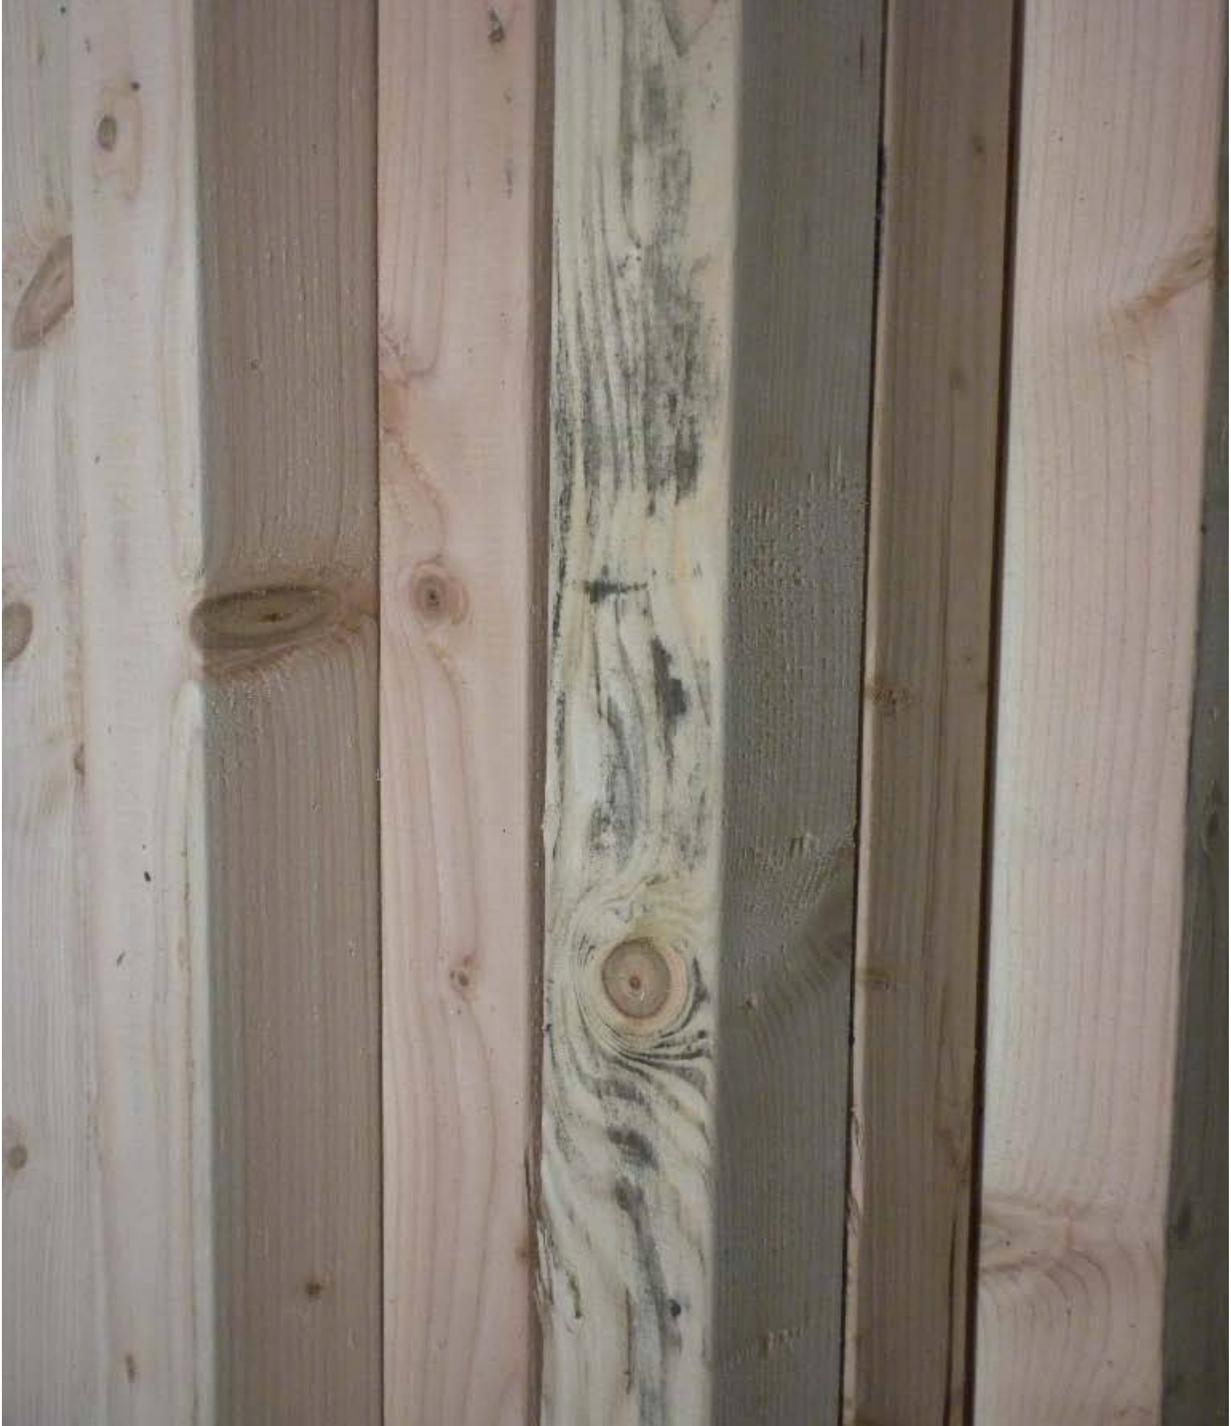
Which piece of wood has sap staining (lumberyard mold)?

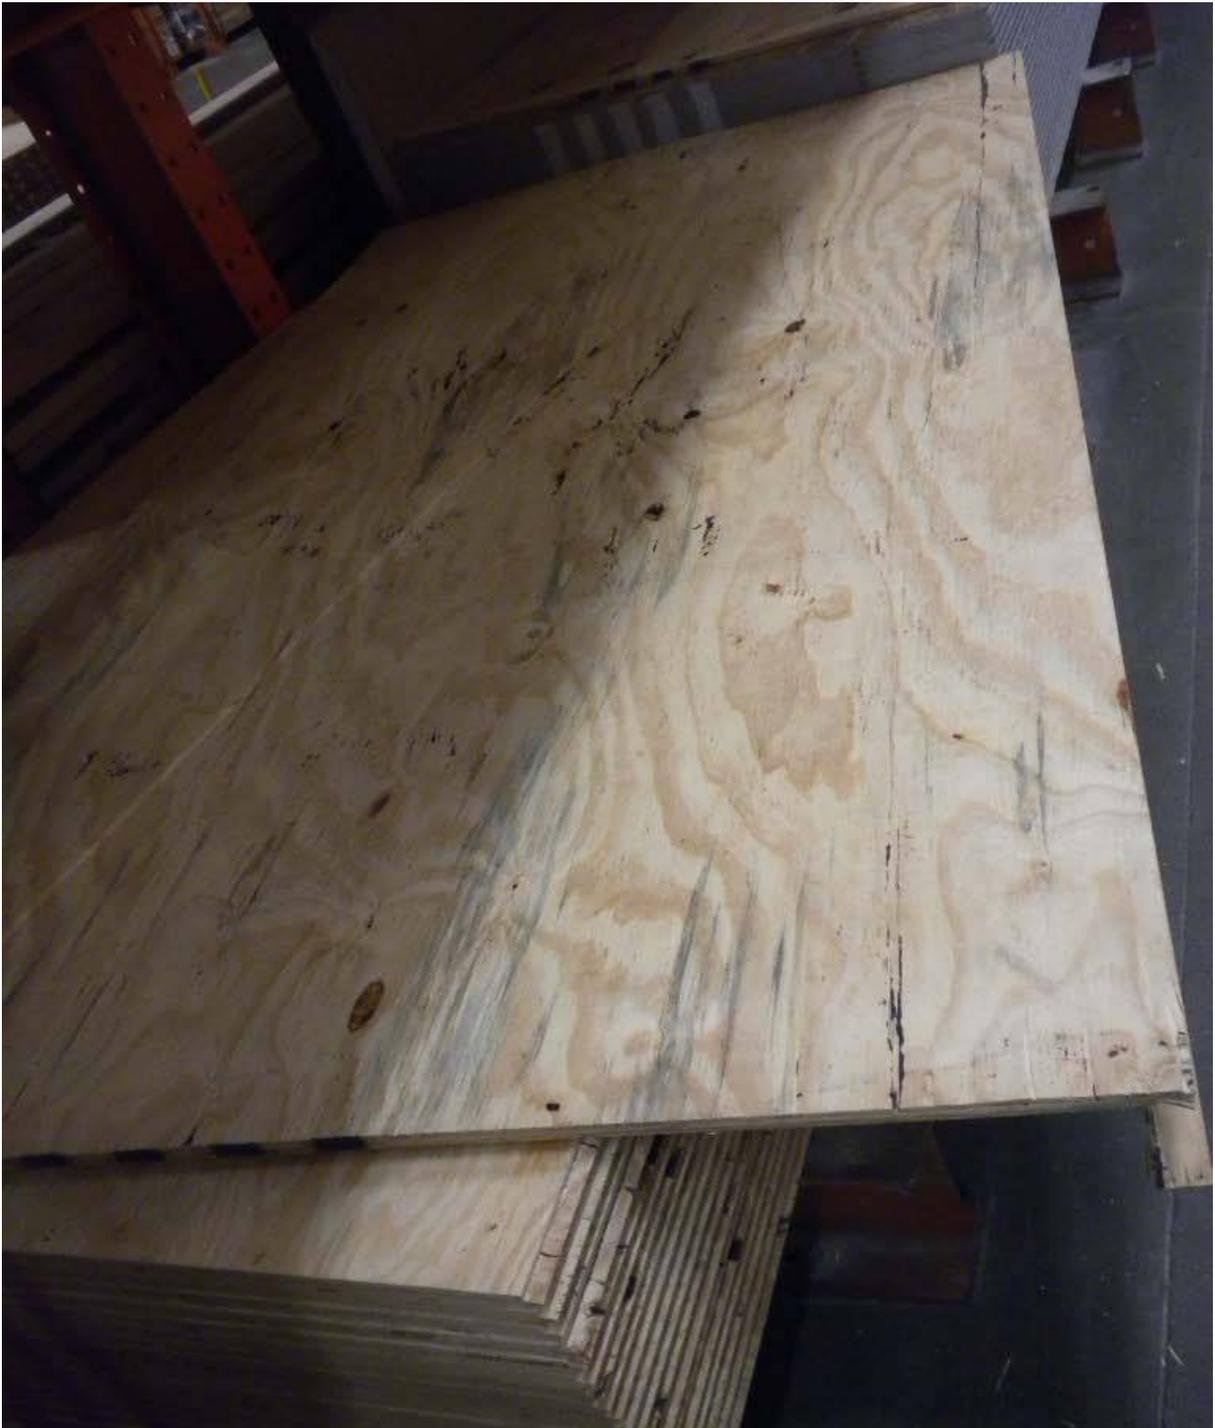
Picture shows wood panel having deep blue sap staining. Investigation showed sap staining is on every panel. Since panels are made in plies the middle ply may have sap staining. Should these panels not be used in building construction?

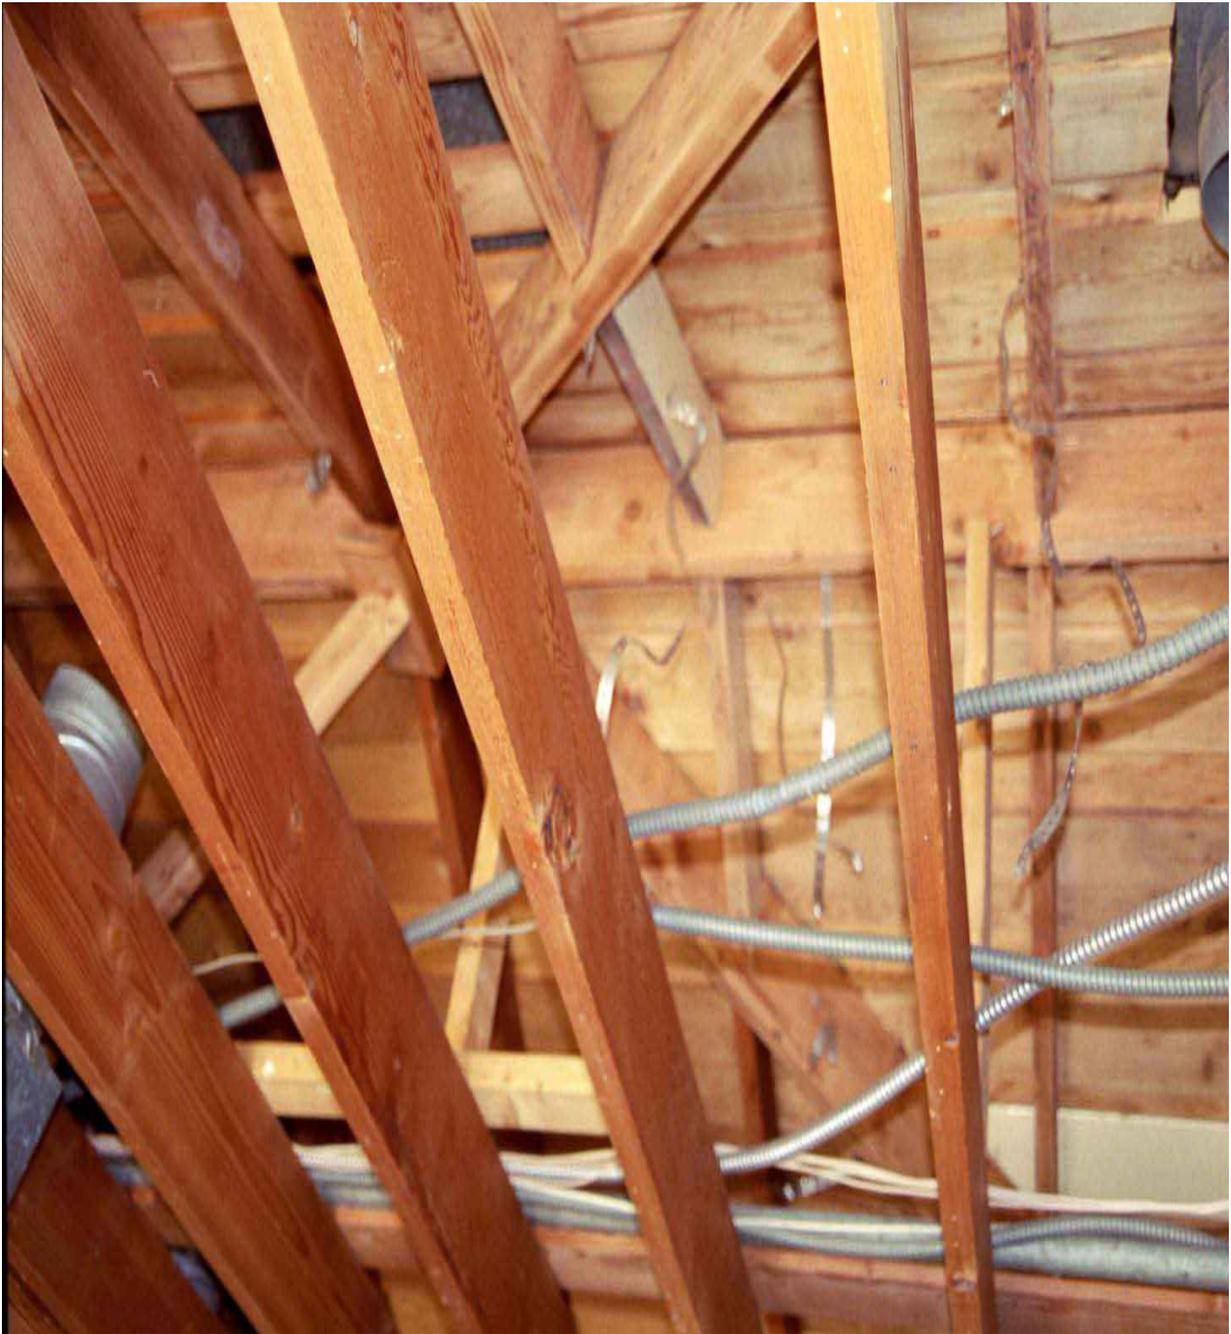
After mold remediation, picture shows building framing without visible signs of mold growth and lumberyard mold. One can see the graining of wood where there is lighter and darker coloring.

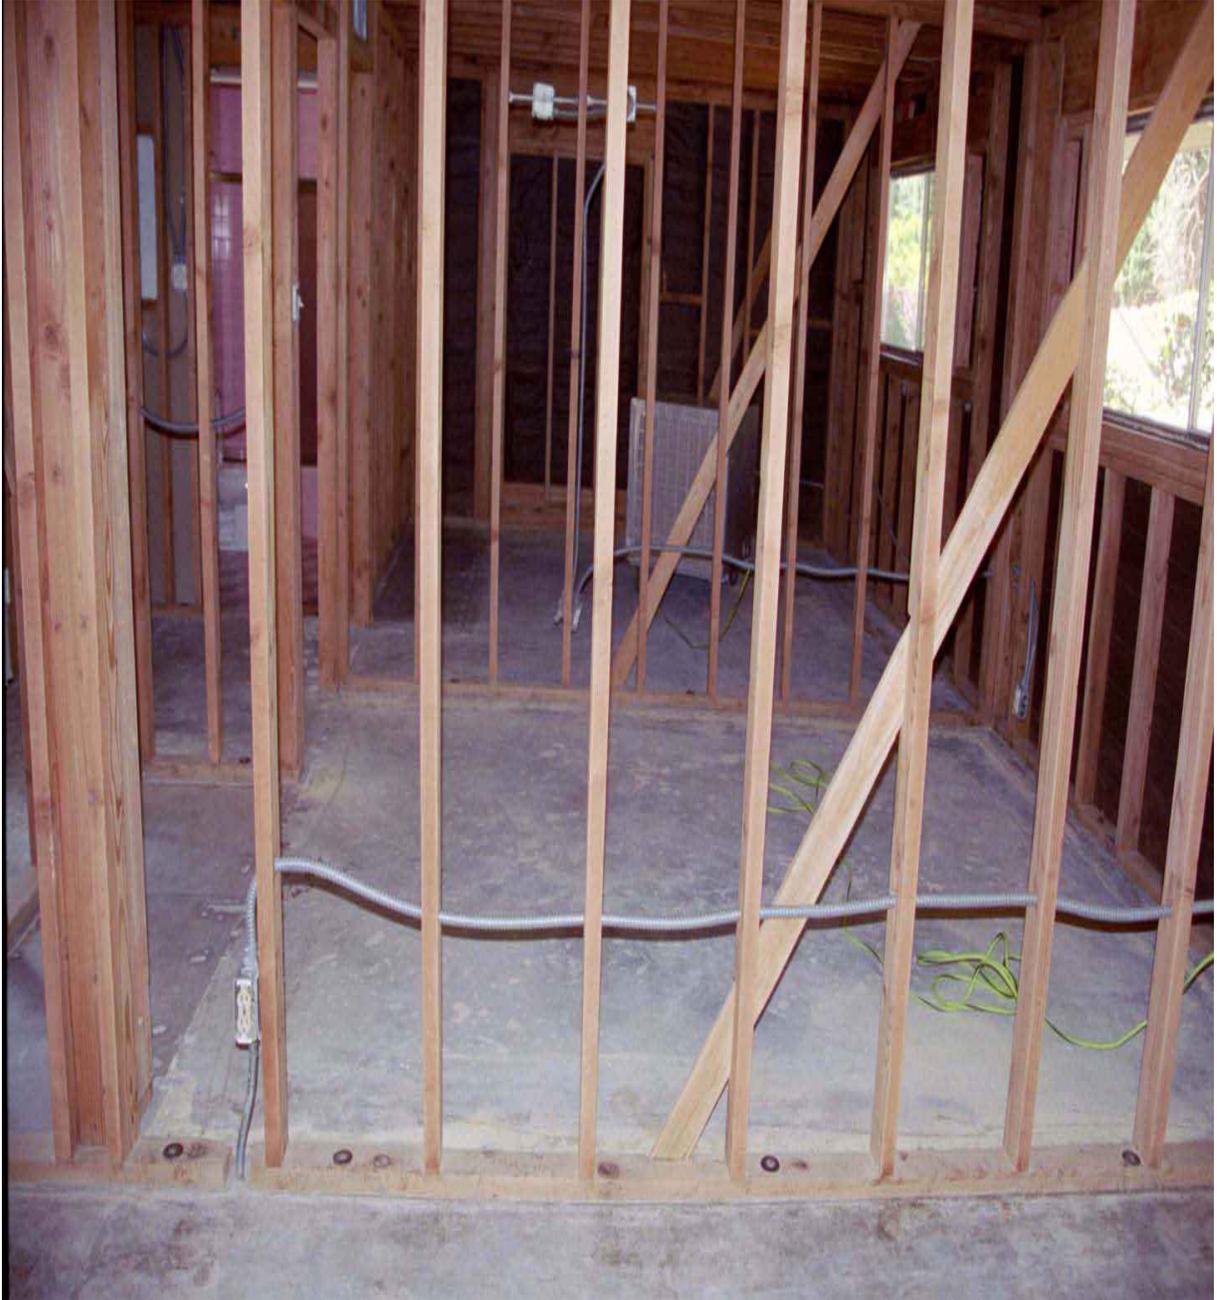
Building framing after mold remediation.

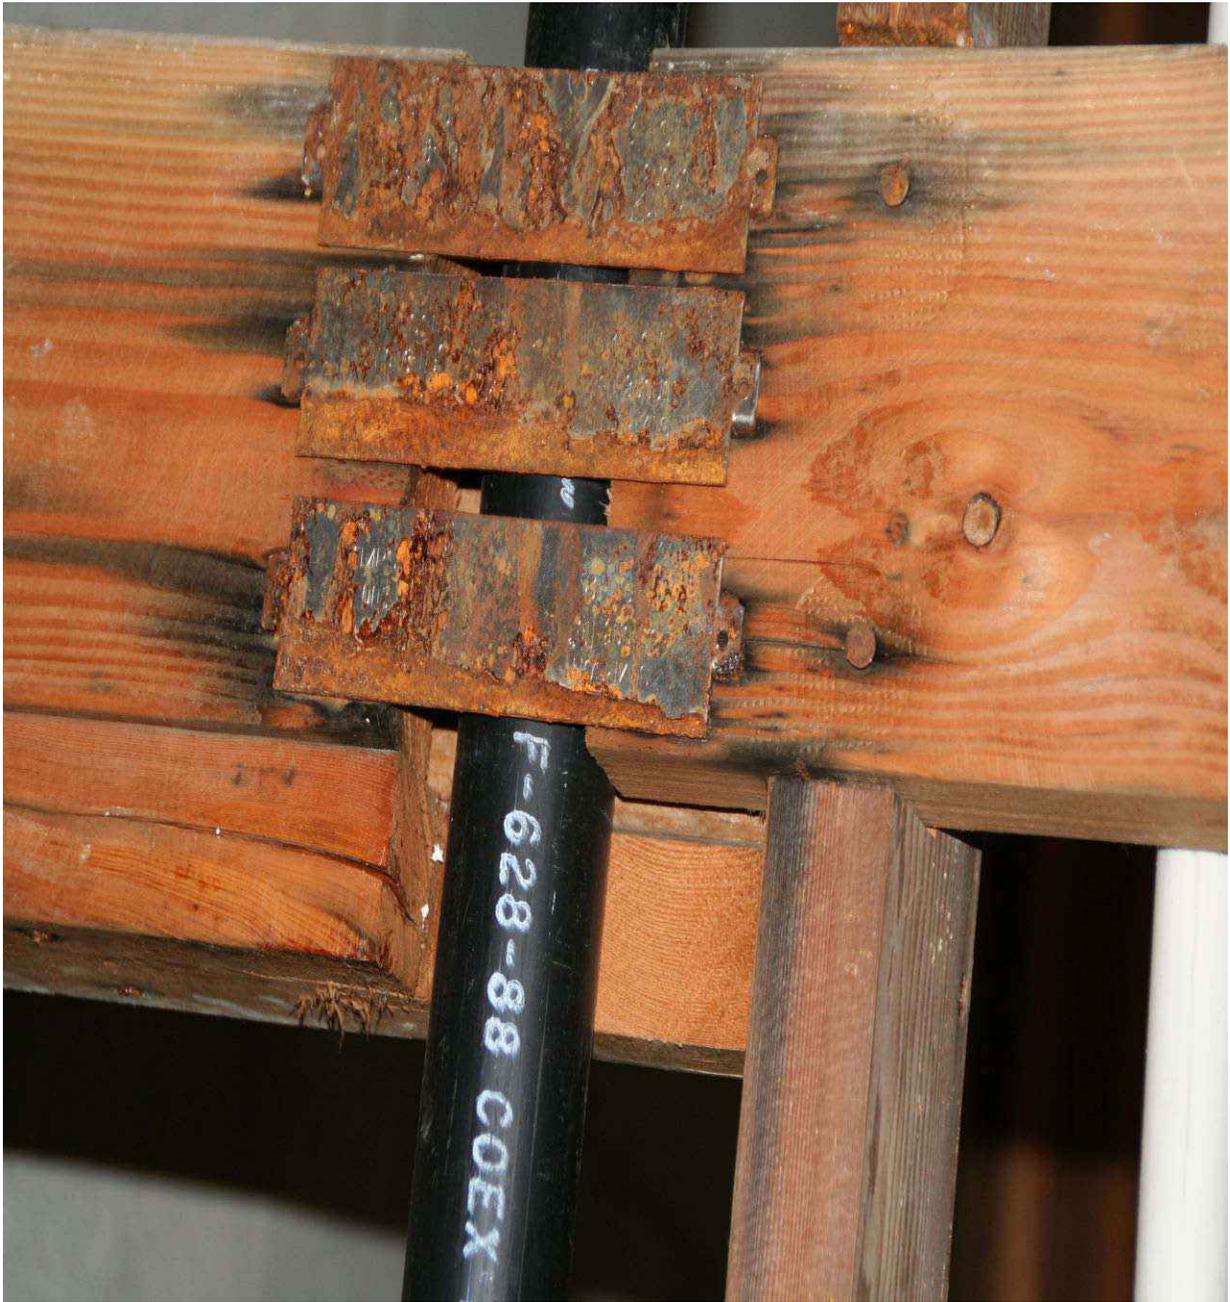
Building framing with wood staining from metal clips (staples).

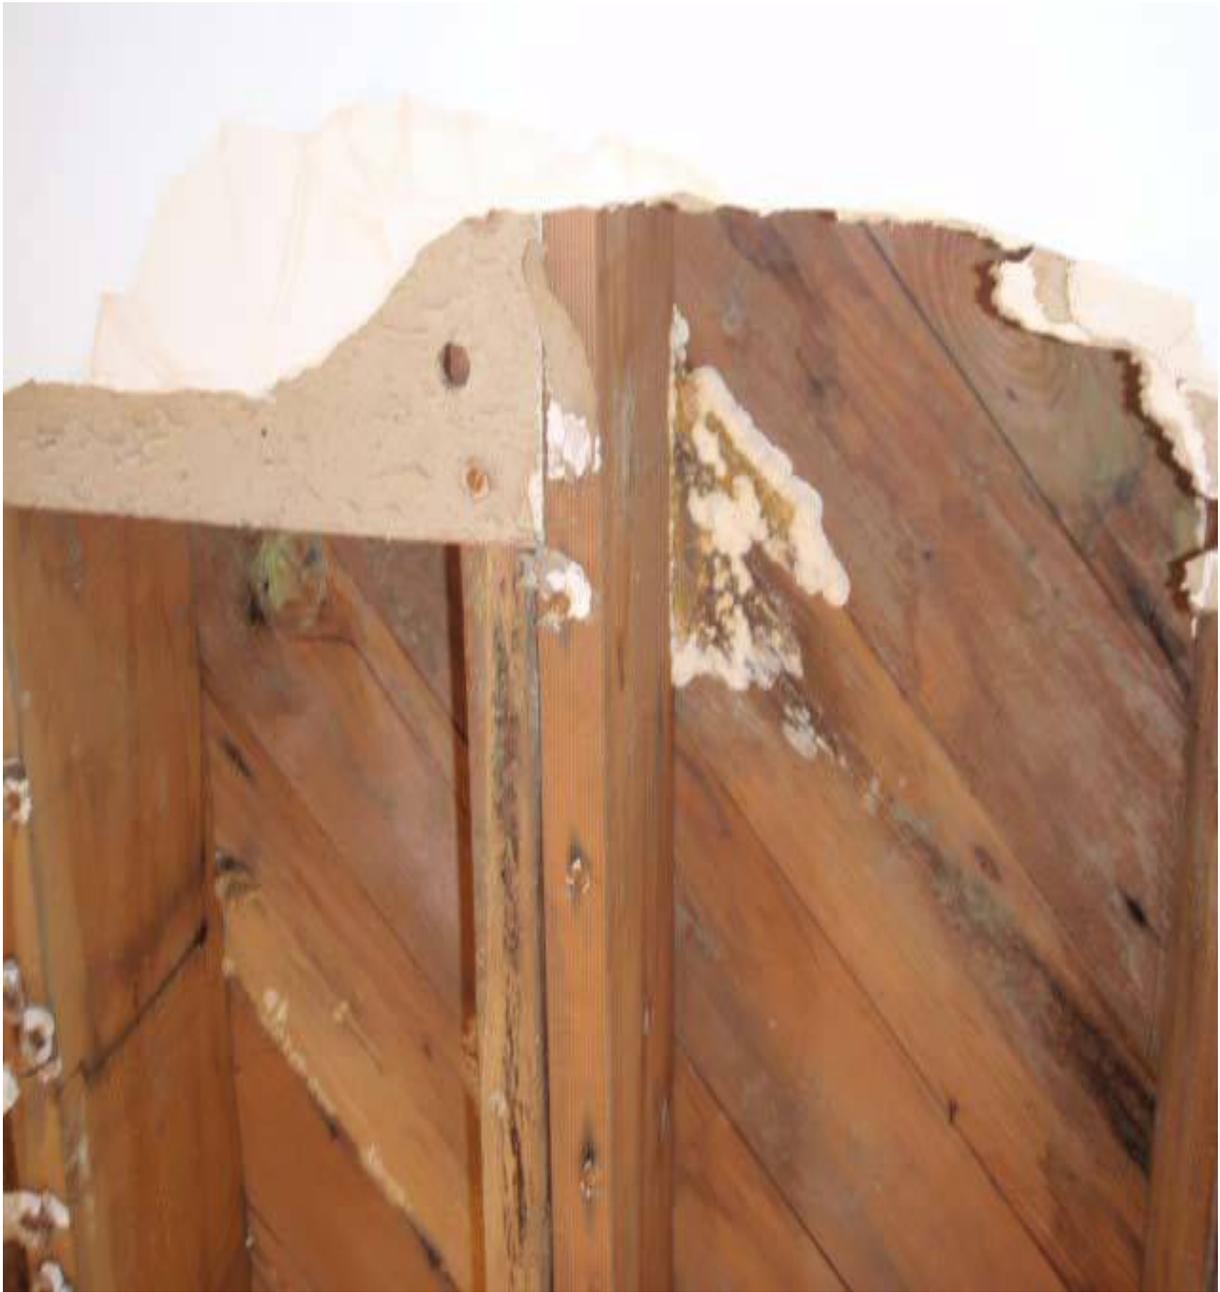
Many issues are in this picture involving mold growth from water damage including the second floor subfloor, first floor ceiling joists and drywall. From this picture can you identify the lumberyard mold?

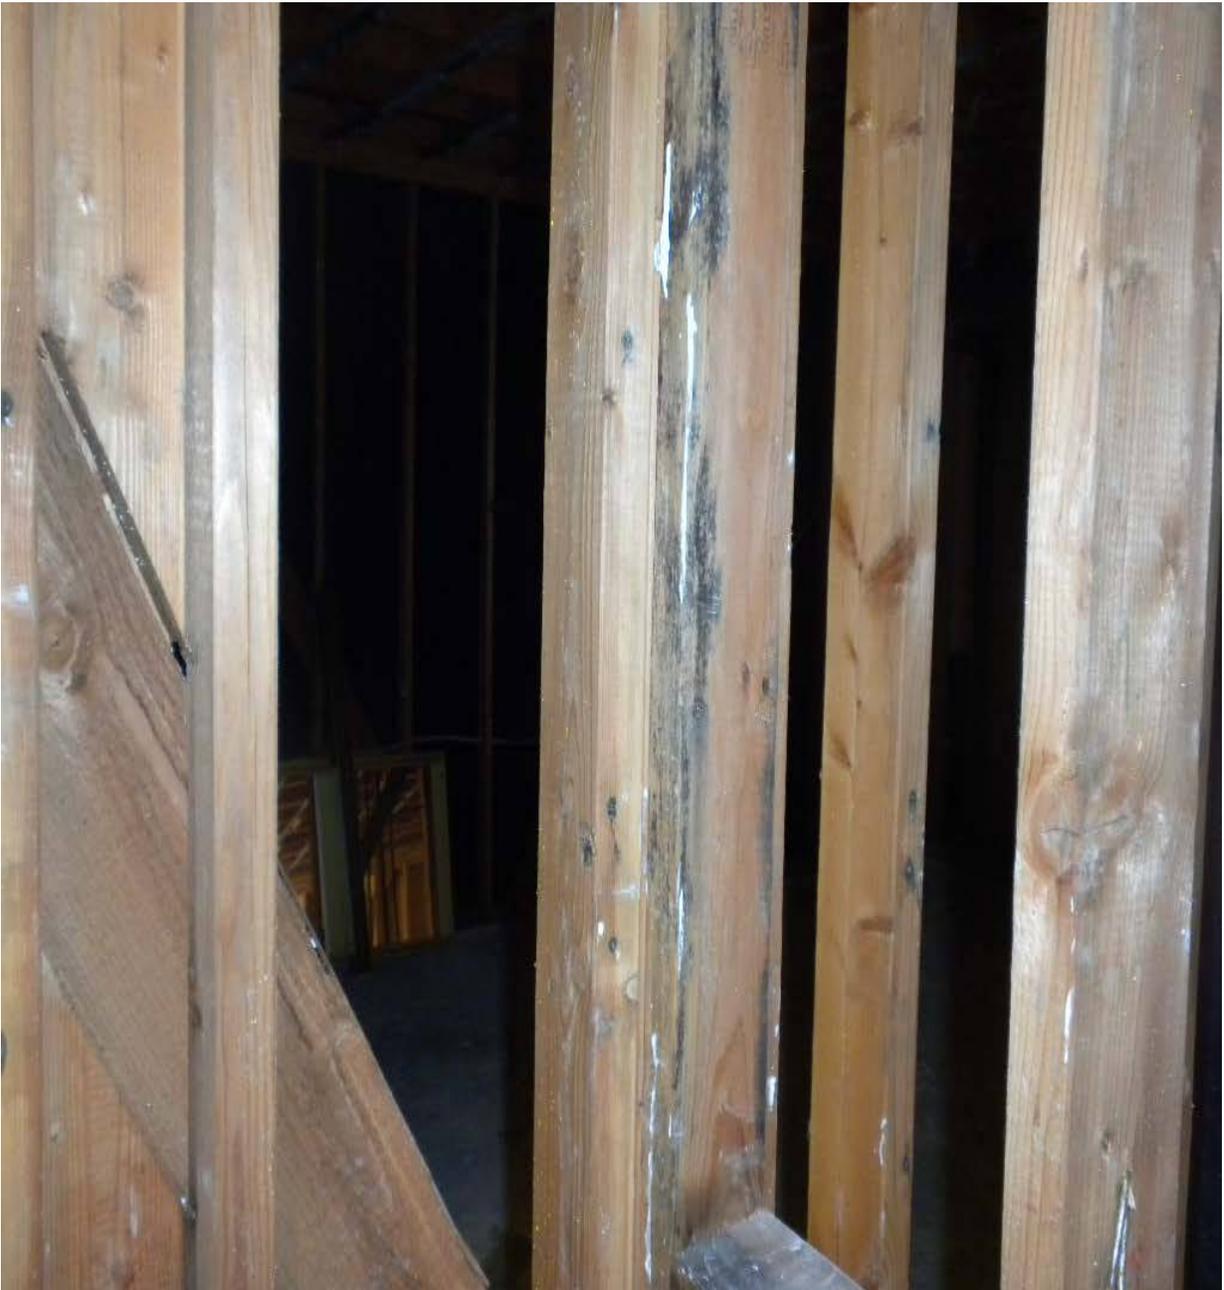
Heartwood doesn't support sap staining but the lighter color sapwood will. From the picture above can you tell what sections of lumber are made from heartwood and sapwood? Which piece of lumber has sap staining?
